**Research Request:**

I am looking for aircraft accidents/incidents that occurred during the servicing of aircraft crew or passenger oxygen (fires,etc.).

**Research Response:**

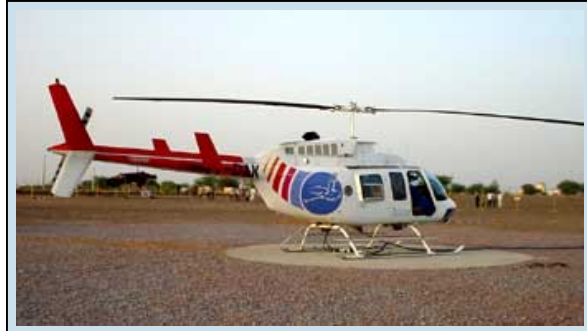
**EMS Helicopter**

In the case of this accident, an explosion occurred while servicing medical oxygen. A Bell 206 EMS helicopter pilot was slowly opening a medical oxygen valve in the baggage compartment when the explosion occurred. The pilot was thrown from the helicopter and severely injured. The ATSB (Australian Transportation Safety Board) determined the explosion source was a high pressure hose between the oxygen regulator and oxygen pressure gauge. The ATSB stated the system was not adequately cleaned, used a poor quality adapter, and used a flexible hose that was not the best type to use for the system. The ATSB also stated there was a general lack of knowledge among flight crews on the proper use and dangers of oxygen.

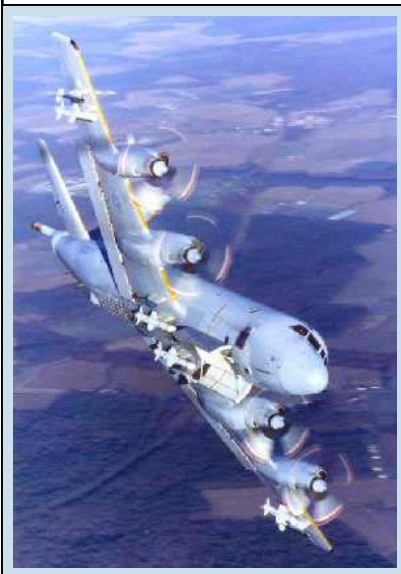
**U.S. Navy P-3's**

In 1998 and 2003 U.S. Navy P-3's experienced two oxygen-related fires while on the ground. Both aircraft were destroyed as a result of the fires. The cause of the fires was determined to either be due to compression heating or particle impact from an oxygen leak. A NASA research report on the accidents stated, "It was surmised that the fire started due to heat generated by an oxygen leak past a silicone check valve seal or possibly because of particle impact near the seat of one of the MCV assembly check valves. An additional analysis of fires in several check valve poppet seals from other aircraft is discussed. These burned poppet seals came from P-3 oxygen systems that had been serviced at the Naval Air Station in Jacksonville following standard fill procedures. It was concluded that these seal fires occurred due to the heat from compression heating, particle impact, or the heat generated by an oxygen leak past the silicone check valve seal. The fact that catastrophic fires did not occur in the case of each check valve seal fire was attributed to the protective nature of the aluminum oxide layer on the check valve poppets. To prevent future fires of this nature, the U.S. and Canadian fleets of P-3 aircraft have been retrofitted with MCV assemblies with an upgraded design and more burn-resistant materials."

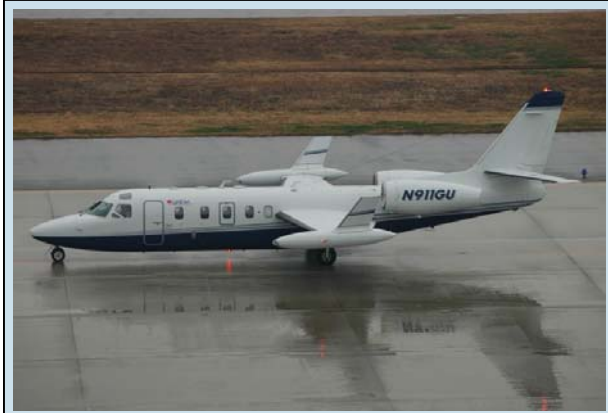
**Israeli Aircraft Industries 1124**

This particular accident occurred while the crew was testing the flow of oxygen in February 1995. A fire immediately ensued and luckily everyone was able to escape uninjured. It was revealed the oxygen cylinder was contaminated, thus causing the fire.

DURING PREFLIGHT OF THE AIRPLANE, THE FIRST OFFICER OPENED THE MAIN OXYGEN SUPPLY VALVE IN THE COCKPIT AND HEARD A LOUD HISSING SOUND. ALMOST IMMEDIATELY THEREAFTER, THE COCKPIT WAS ENGULFED IN FLAMES, BUT THE COPILOT WAS ABLE TO ESCAPE. HE EXITED THE AIRPLANE UNINJURED. THE FIRE MELTED THE OXYGEN SYSTEM PRESSURE REDUCER-REGULATOR ASSEMBLY, BURNED A HOLE IN THE RIGHT FORWARD SIDE WALL OF THE AIRPLANE, AND CAUSED SUBSTANTIAL DAMAGE TO THE CABIN INTERIOR BEFORE IT WAS EXTINGUISHED BY RAMP PERSONNEL. A LABORATORY ANALYSIS DISCLOSED THE PRESENCE OF OIL IN A 'DEPOSIT' FOUND ON THE INTERIOR OF THE OXYGEN CYLINDER.

AN OXYGEN LEAK AT THE OXYGEN SYSTEM PRESSURE REDUCER-REGULATOR ASSEMBLY, RESULTING IN A CREW COMPARTMENT FIRE.
