ASOS Research Request

ASOS Research Brief

NTSB Detail: CHI94FA116

NTSB Detail: BFO90MA023

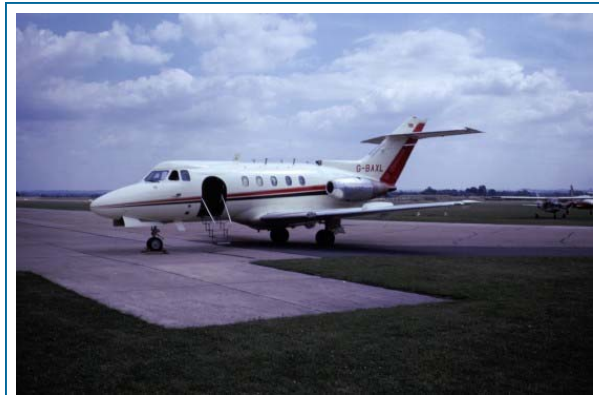
G-0B0B, when she was G-BAXL in better days.

The first one occurred on January 30th, 1990 and involved a British Registered Hawker crashing near Columbia, Missouri. The NTSB report is brief. *"PROBABLE CAUSE: "Inadequate pre-flight by the pilot(s), water contamination of the fuel, low level of deice fluid (methanol) in the deice tank, and subsequent ice blockage of the fuel filters."* The pilot was killed and the co-pilot and passenger suffered injuries.

INADEQUATE PREFLIGHT BY THE PILOT(S), WATER CONTAMINATION OF THE FUEL, LOW LEVEL OF DEICE FLUID (METHANOL) IN THE DEICE TANK, AND SUBSEQUENT ICE BLOCKAGE OF THE FUEL FILTERS. DARKNESS WAS A RELATED FACTOR.

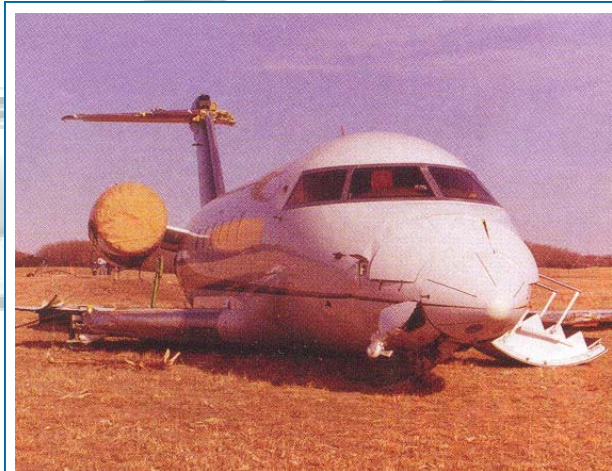
N88HA, Crystal Aviation's Challenger after the dual engine flameout at Bassett, NE, 03/20/1994.

the pilot in command's inadequate planning/decision making and inadequate preflight inspection after receiving a load of contaminated fuel. Related factors are the contaminated fuel, improper refueling by FBO personnel, and the dark night light
