RESEARCH BRIEF

Research incidences of insect/wasp infestations in an aircraft's pitot/static system.

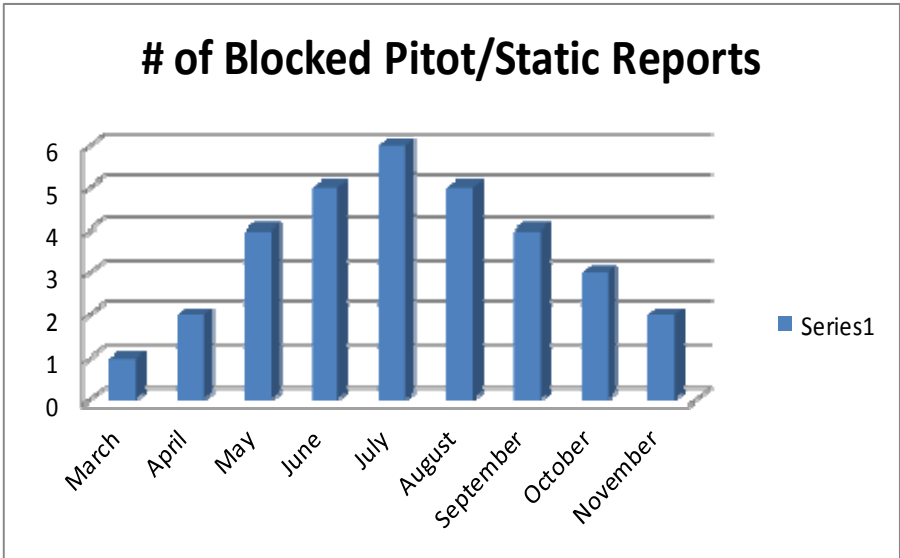
From 1983 forward there have been a total of 114 incidents reported to the NTSB, FAA, and NASA which involve insects blocking aircraft systems. Of those 114 reports 32 were related to a blocked pitot static system as a result of an insect. Below is a graph of the findings.

As shown by the graph, the majority of the events were reported during the summer months. Not all reports included the state where the incident occurred; however, of the reports that did include a state a geographic trend could not be determined. The states ranged from CA, OR, TX, NY, NC, MI, MO, NM, UT, CO, FL, AR, AL, PA, & VA.

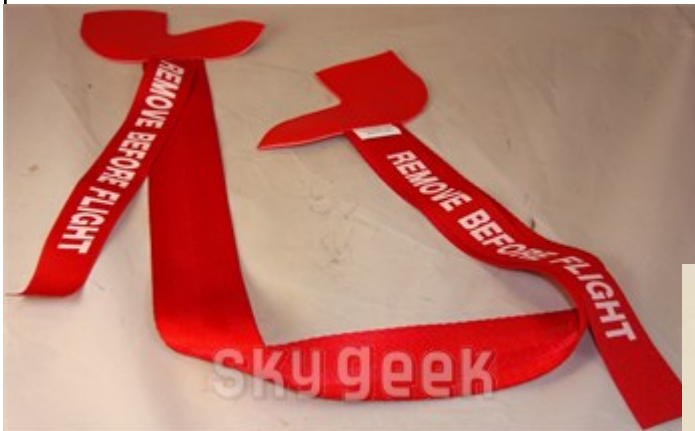
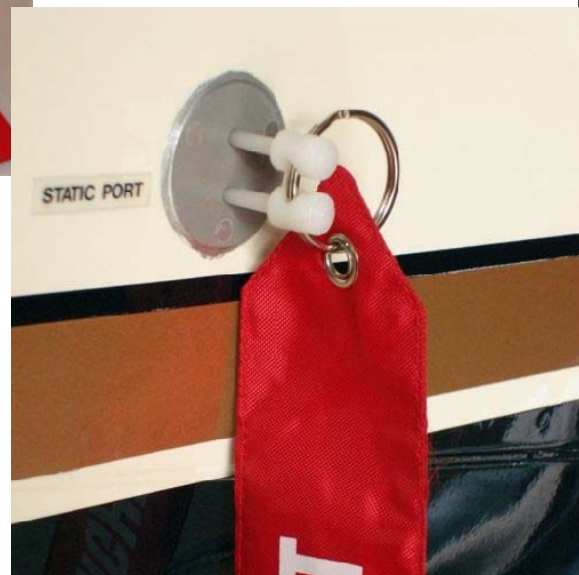
Mud daubers were identified as the culprit in majority of the reported blocked pitot tube events. They are slender wasps whose nests are composed of a series of cylindrical cells resembling an organ pipe. Reports identified no other specific insect species.

The mud daubers' manner and speed of nesting can cause significant issues because of how fast they can build a nest inside of a pitot tube and how hard it can be to identify the tube as blocked during a pre-flight inspection. In the majority of reported events most pilots did not identify a blockage problem with the pitot static system until they were already in the air.

Based on the NTSB, FAA Accident/Incident Data, and ASRS reports it is recommended that pitot tube covers and static port plugs are used any time an aircraft is shutdown and parked even if it's only for a couple of hours. In addition to using covers a thorough pre-flight inspections should be conducted. Sometimes a mud dauber nest in the pitot tube can be discovered by identifying dirt around the drain hole.
