**Research Request:**

Turbine powered fixed-wing aircraft that have departed a contaminated runway during the takeoff sequence.

**Analysis of Contaminated Runway Takeoff Accidents**

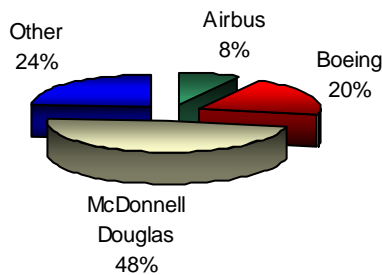
**Make / Model of Turbine Aircraft involved in Contaminated Runway Accidents during Takeoff**

A break-down of the 25 accidents discovered in the database shows that 19 were operating underneath an airline and 6 were operating as private business aircraft. 20 of the aircraft involved were turbojets, the remaining 5 were turboprop.
