### **ROTARY WING NEWSLETTER** December 2022 | Volume XXII | Issue XII

# **SAFETY**WIRE

## Tips to Avoid Collisions Between Drones and Helicopters: A Case Study from a Near-midair Collision

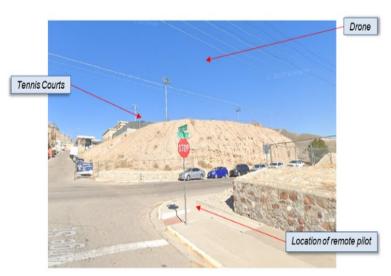
Figure 1. (Photo courtesy of Google)

The remote pilot was operating the drone from a sidewalk located at the base of a small hill. The tennis courts were located atop a hill across the street (see figure 1).

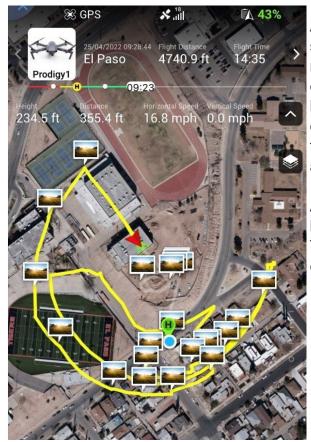
Figure 3. This is the flight path flown during the inspection of the tennis courts. The flight path illustrates how the remote pilot flew several wide arcs to the south and west of the tennis courts. (Photo courtesy of Michael McGee)
