DEKALB-PEACHTREE AIRPORT

KPDK

Chamblee, GA

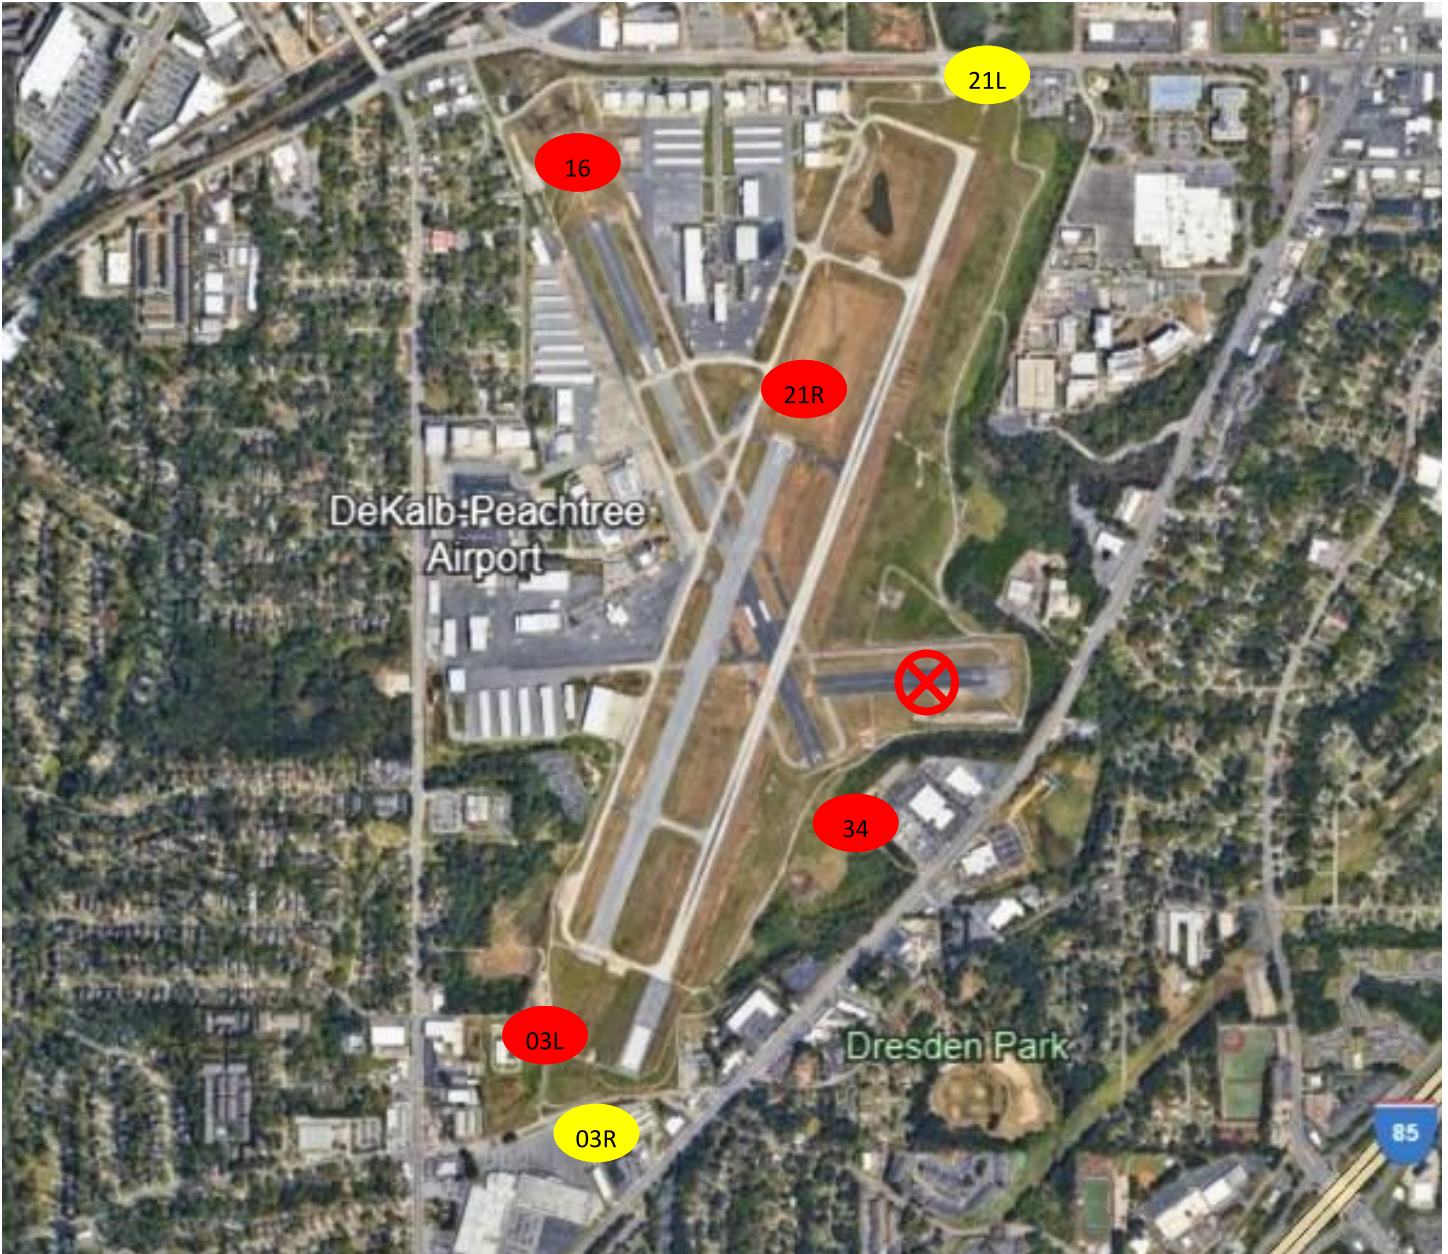
CAUTION
Airport Hot Spots

Hazard	(Optional) Mitigations—Please fill in your own company mitigations
Small airport layout with extremely busy operations.	
Short runway operations increases risk of unstable approach and runway excursion.	
Taxi routes require runway crossings.	
Airport Hot Spots, see pg 3.
