KASE Elevation 7838' Aspen, CO

## Airport Website

### **Airport Overview**

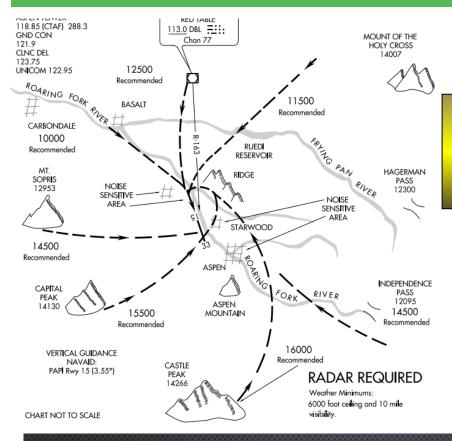
### **CAUTION**

**Mountainous Terrain All Quadrants**

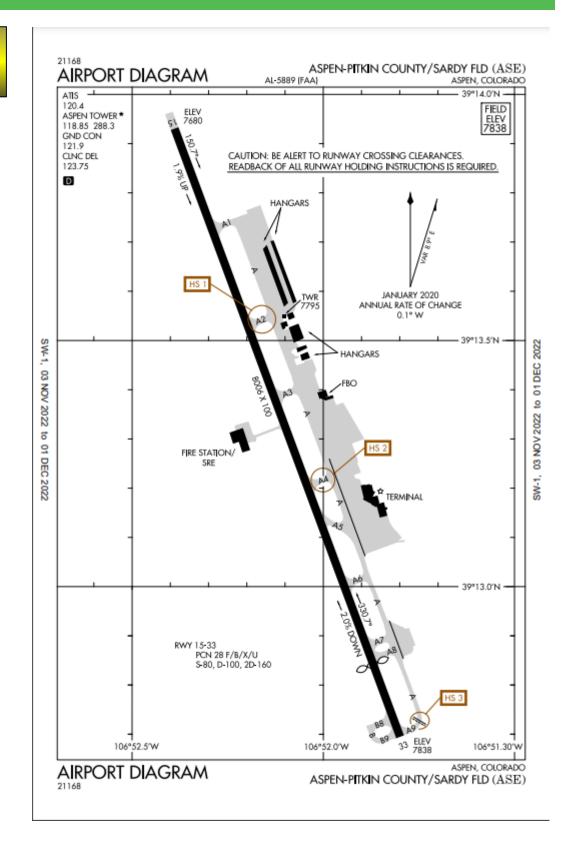
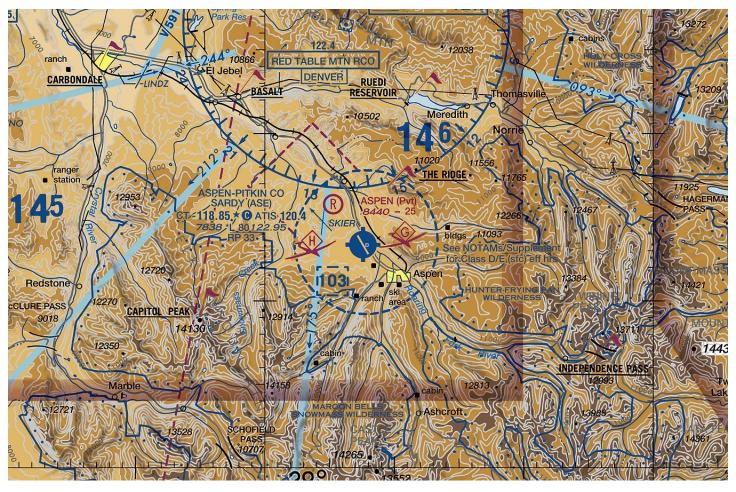
**Airport Hot Spots**

**CAUTION**

- CFIT due to nearby mountainous terrain on both approach and missed approach/balked landings.
- RWY 15 has 2% up-slope; RWY 33 2% down-slope.
- Airport Hot Spots, see pg 7.
- High elevation airport effects on aircraft performance.
- Higher than standard glidepath gradients increase risk of unstable approach.
- No full length parallel taxiway increases risk of runway incursion.
