Research Request:

Learjet engine flameouts– Lear 20/30/40/50/60 series aircraft.

Research Response:

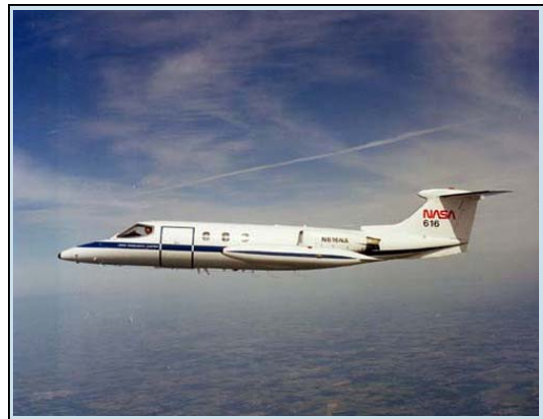
Altitude

- 5 flameouts occurred between FL390 and FL410.
- 1 report occurred at 5,000ft.
- The altitude was not specified in 10 reports.

Single-Engine Flameouts

- 10 reports were single-engine flameouts.

Dual-Engine Flameouts

- 6 reports were dual-engine flameouts.

Engine Restart

- 5 reports stated an engine restart was successful. Only one restart was a dual engine flameout restart.
- 5 reports stated no restart was accomplished.
- An engine restart was not specified in 6 reports.

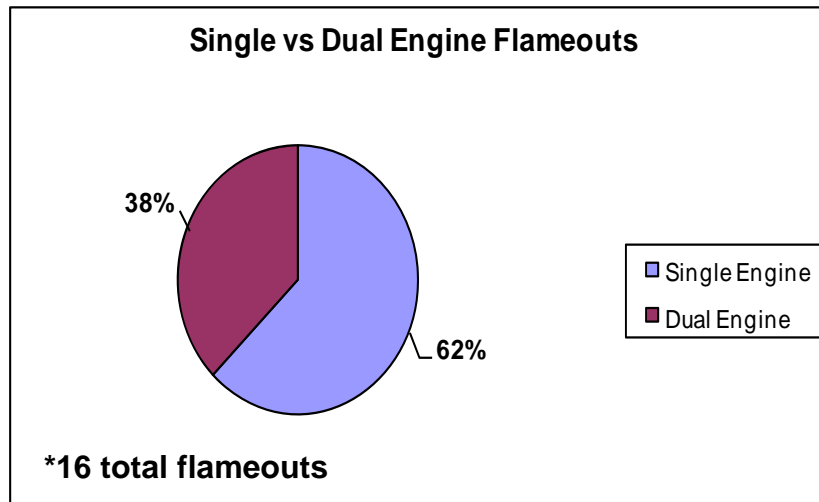
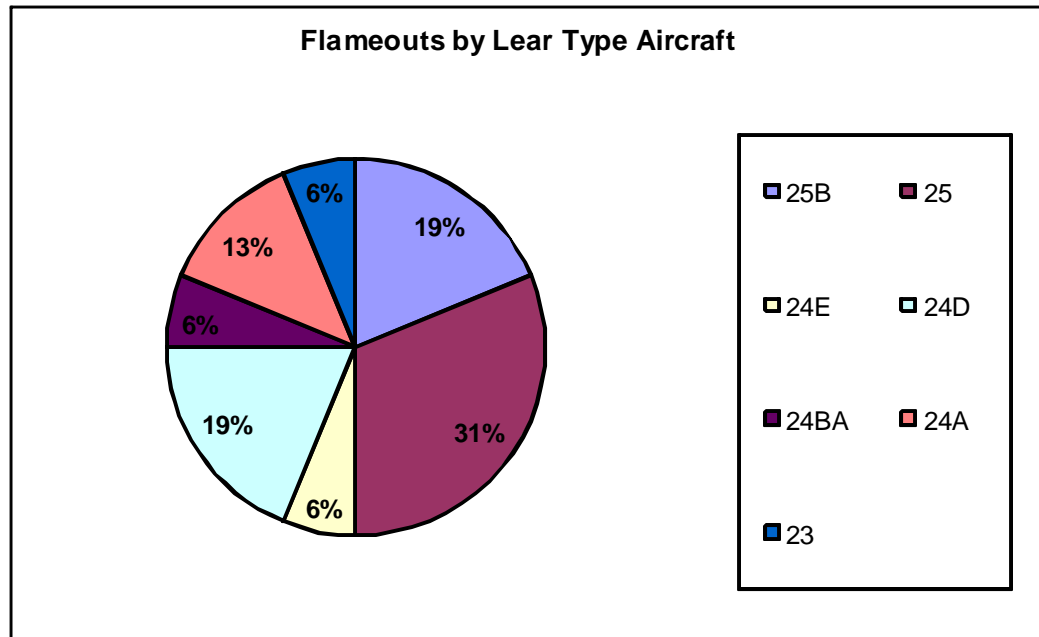
Research Results

Lear	Additional Info	Altitude	Single Engine	Dual Engine	Restart	Contributing Factor
25B		UKN	Yes		No	SUPPORT ARM FOR INLET HEAT DUCT SLIPPED, DEFLECTED AIR.
25B	Occurred on climbout	UKN		Yes	UKN	BIRD RESIDUE ON ENGINES. ENGINE AIRFLOW REDUCED
25B		390	Yes		UKN	MALFUNCTION OF FUEL CONTROL
25		410	Yes		Yes	UKN
25		UKN	Yes		Yes	UKN
25		390		Yes	UKN	UKN
25		UKN	Yes		No	INLET SENSE LINE UNINSULATED.
25		5000		Yes	No	UKN
24E		410		Yes	Yes	UKN
24D	Turbulence during climb in t-storm.	UKN		Yes	UKN	UKN
24D	Flight into severe weather			Yes	No	UKN
24D		UKN	Yes			BIRD STRIKE ON CLIMBOUT
24BA		UKN	Yes		No	STARTER GENERATOR HAD FAILED
24a	Turbulence	UKN	Yes		UKN	UKN
24a		UKN	Yes		UKN	SHEARED FUEL PUMP DRIVE
23		410	Yes		Yes	UKN

*UKN indicates 'unknown' - the data was not present
