Research Request:

What atmospheric conditions are more conducive for lightening strikes other than the obvious (i.e. thunderstorms and severe weather)?

In-Flight Aircraft Lightning Strikes

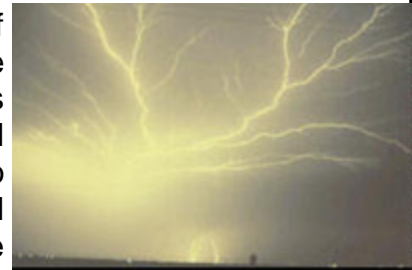
Flux lines always radiate perpendicularly from the charge surface before moving toward their destination (opposite charge location). Given this knowledge, we can say that if the lower surface of the cloud is not straight, the flux lines will not be uniform. Try this: Draw two points on opposite ends of a basketball. Next, draw a line on the basketball that connects the two points. The curvature of the line is analogous to the flux lines in a non-uniform electric field. The lack of uniform force can cause the step leaders to follow a path that is not a straight line to the earth.
