FIXED WING NEWSLETTER

October 2023 | Volume XXIII | Issue X

# SAFETYWIRE

## Excursions: Running Out of Runway and Options

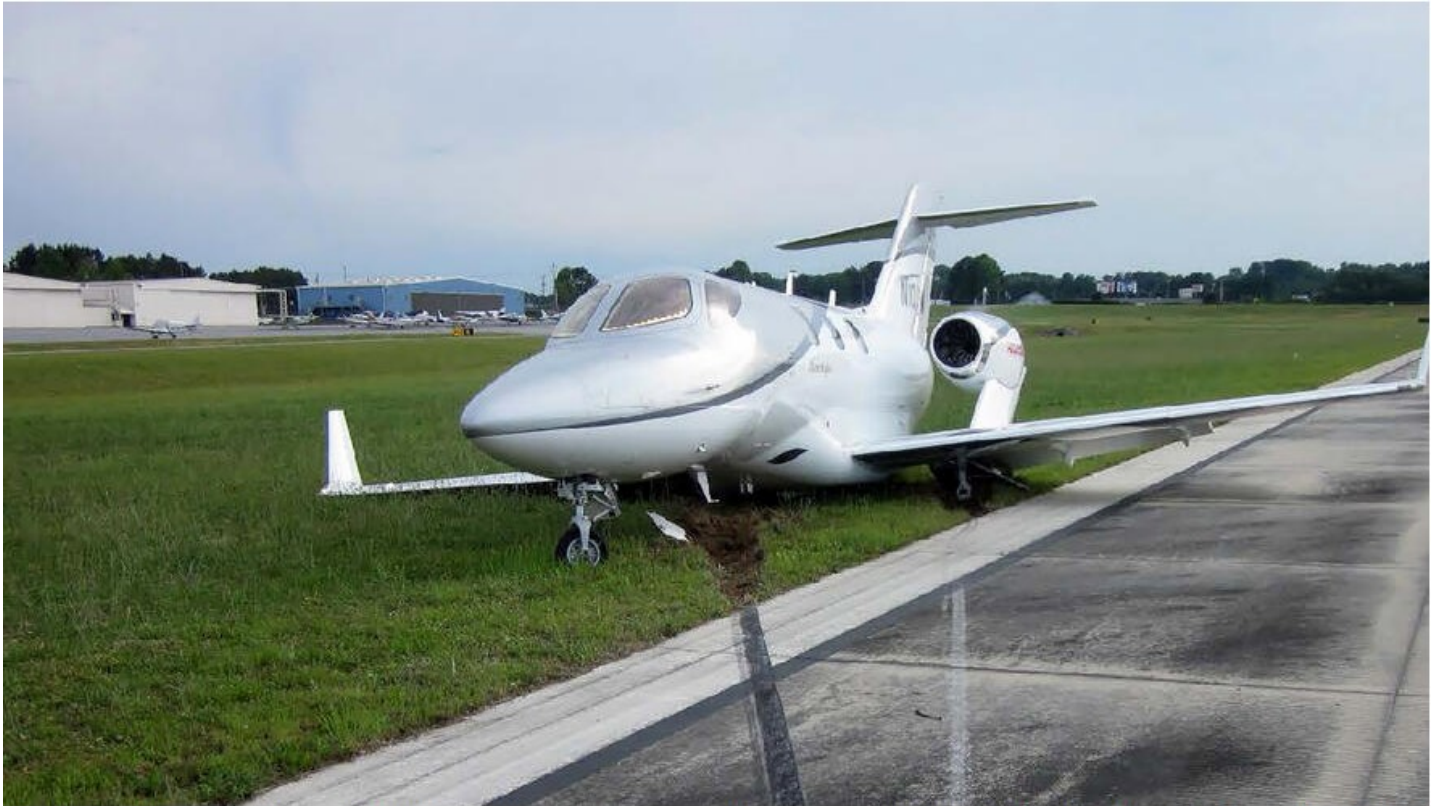
*The NTSB found an improperly installed wheel caused this HondaJet to depart the runway after landing at Atlanta's Cobb County Airport. (Photo: NTSB)*

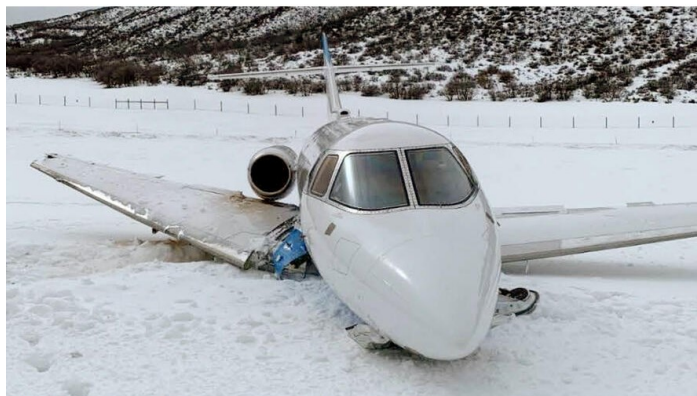
High tailwinds were a factor in this Hawker overrun at Aspen, Colorado. (Photo: NTSB)
