FIXED WING NEWSLETTER

November 2023 | Volume XXIII | Issue XI

# SAFETYWIRE

## Pilots Should Study Runway Condition Reports, Part 1

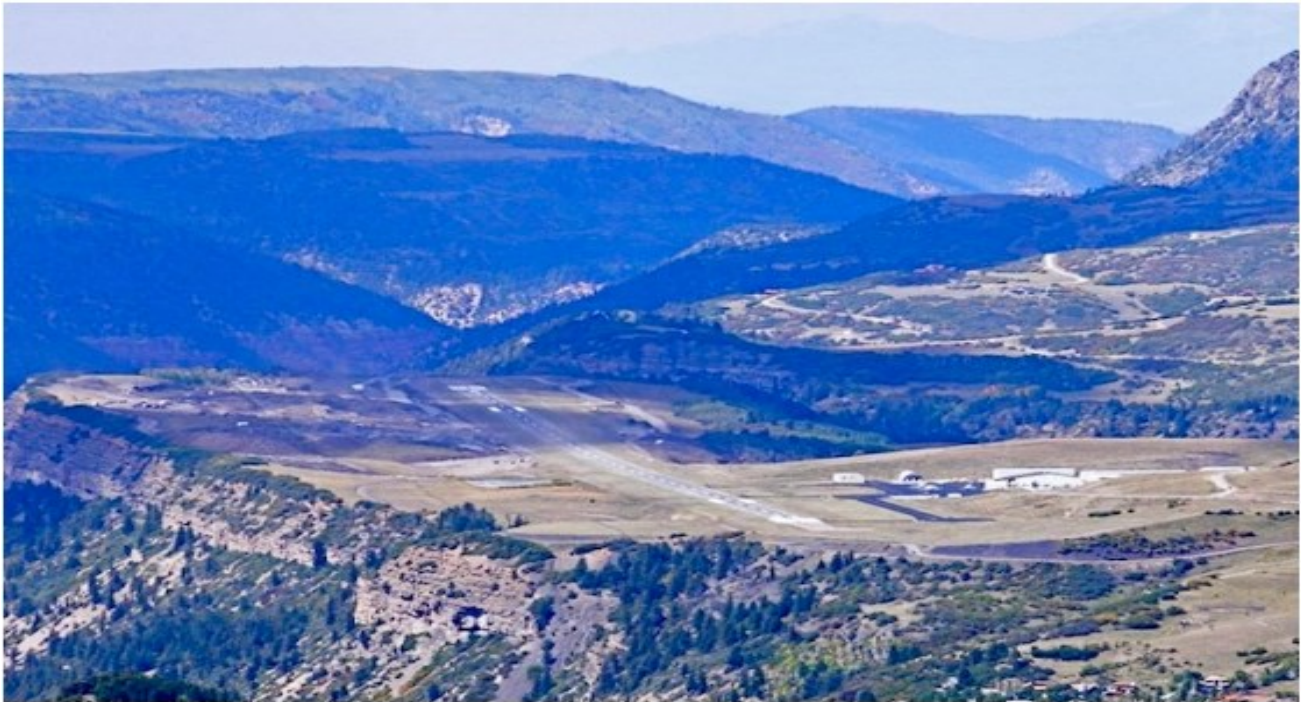
There is potential for strong vertical turbulence at the edge of the mesa collocated with the threshold of Telluride's Runway 09. Credit: Kim Henneman

These effects can be even more pronounced when a runway's threshold is close to vertical terrain. A classic example would be the cliff adjacent to the threshold of Telluride's Runway 9. As the sun's angle moves across the sky and begins to heat that slanted terrain, the air immediately adjacent to the cliff begins to heat and rises rapidly in a thermal.

Aircraft control and flight path maintenance can instantly be compromised by these sudden and surprisingly strong vertical air currents. Incidentally, there is a warning for pilots that the Telluride airport sits on a 1,000-ft. mesa, with the precaution of strong vertical turbulence along the mesa's edge.

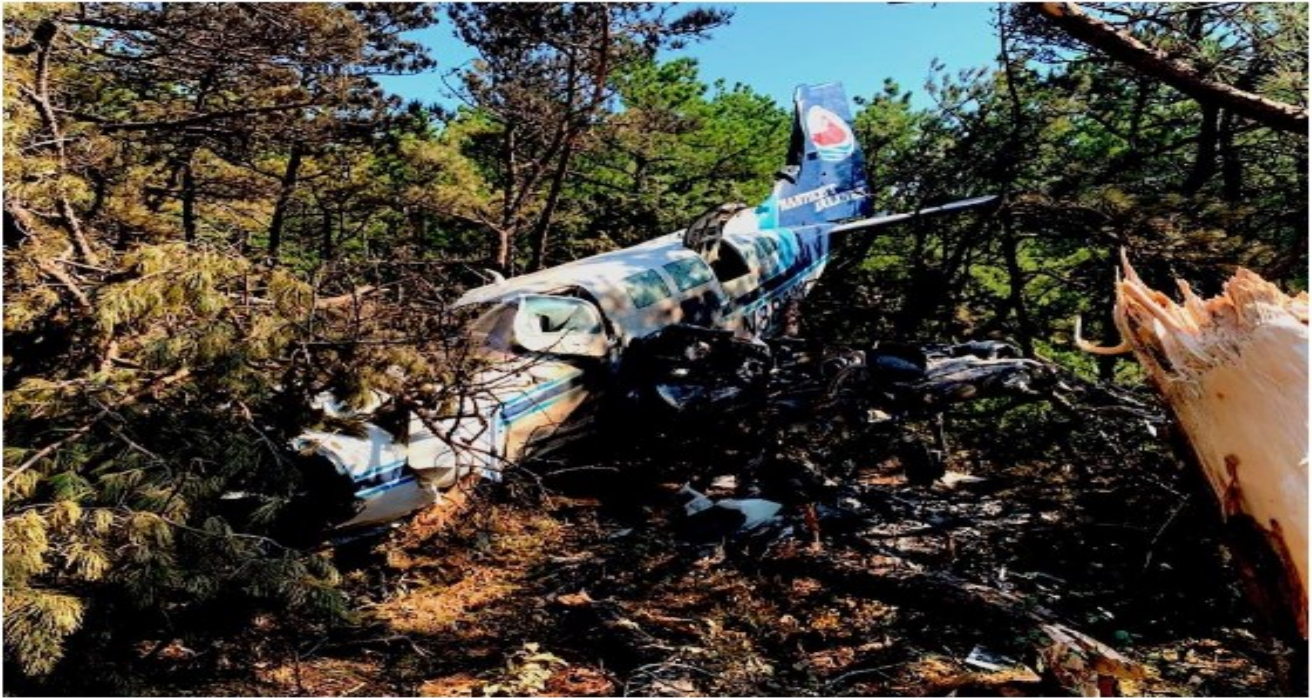
Left side of the airplane after it collided with trees.

He remembered touching down for only about two seconds and did not remember applying the wheel brakes. During the go-around, he was unable to establish a positive rate of climb and the wings were buffeting. The airplane struck a cluster of pine trees about 660 ft. from the departure end of the runway. It then crossed a two-lane road, impacted the ground and more trees before coming to rest. A fire broke out that consumed most of the left wing and a portion of the right wing.

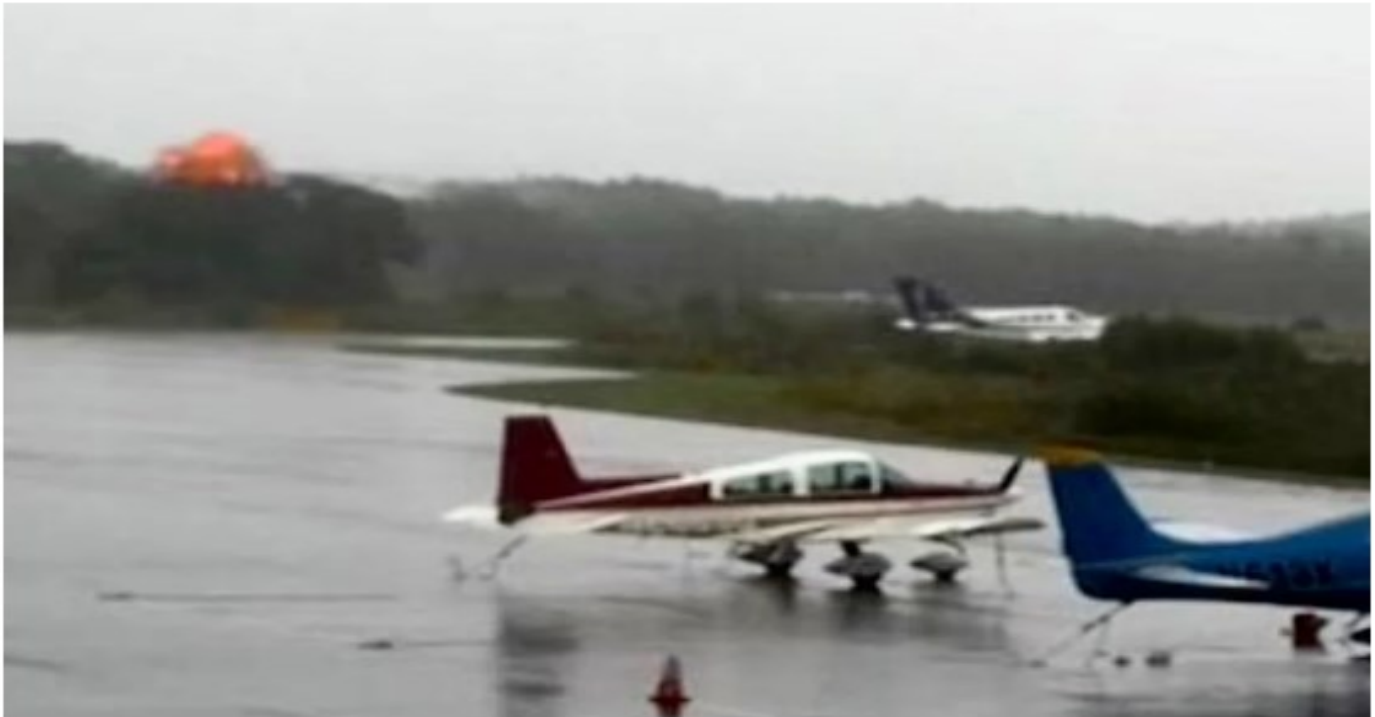
A fireball erupted following the collision with trees. Credit: NTSB
