FIXED WING NEWSLETTER

December 2023 | Volume XXIII | Issue XII

# SAFETYWIRE

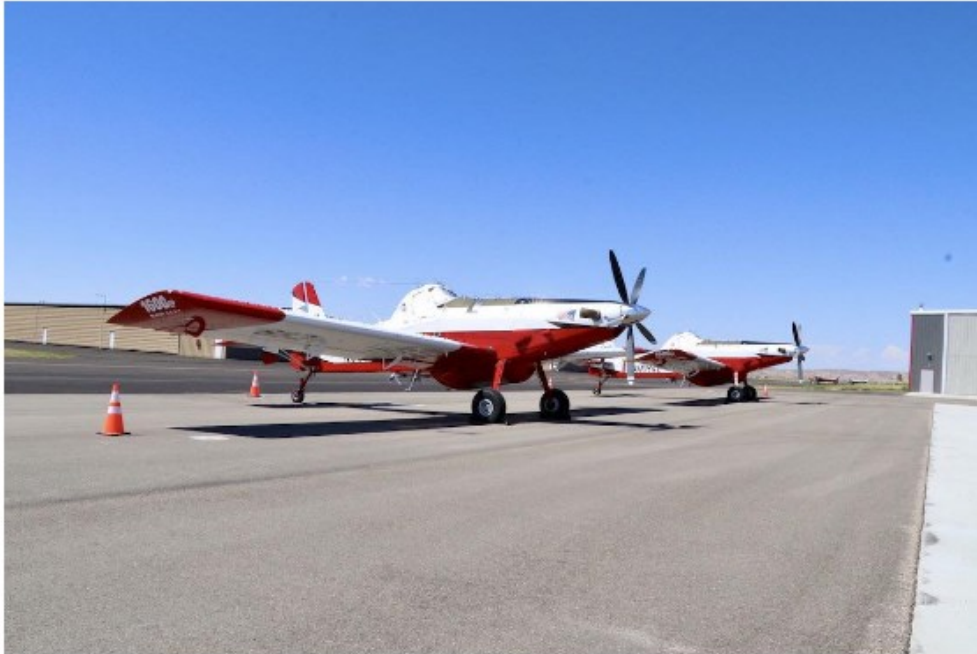
Acres of pavement with scant shade like this Rock Springs, Wyoming, air tanker base turns an airport ramp and runway into its own 'heat island.'

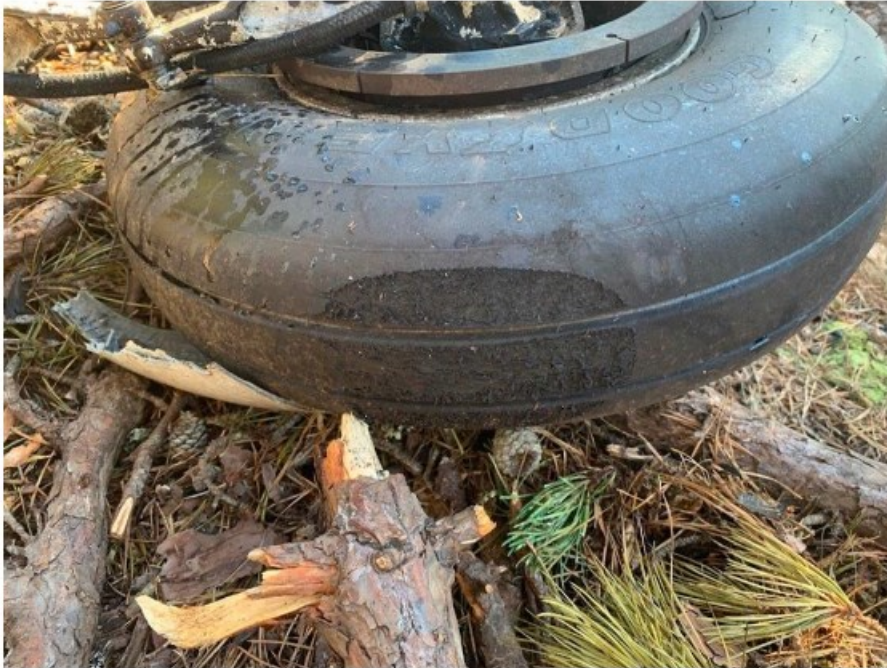
The right main landing gear tire showed areas of melted rubber.

The evidence from the passengers and the tire indicated that, contrary to his recollection, the pilot had first attempted to brake before commencing his go-around.

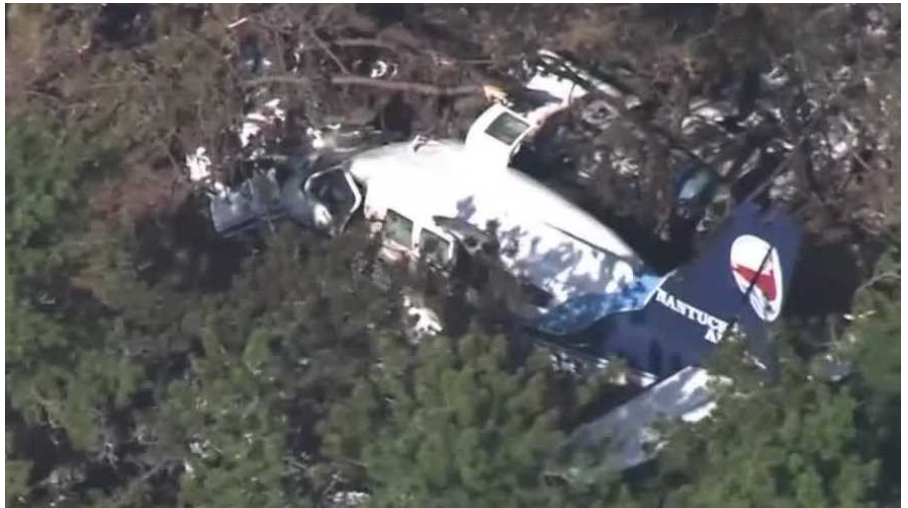
The airplane had two doors and an emergency exit. The pilot's door (crew door) was badly damaged. The emergency exit on the right side of the passenger compartment was open but had been too hot to use. The main door was a two-section, outward opening, airstair door on the left aft side. The top half was open, the bottom half closed. A 5-in. tree limb blocked the lower door half.
