TELLURIDE REGIONAL AIRPORT

KTEX

Airport Overview

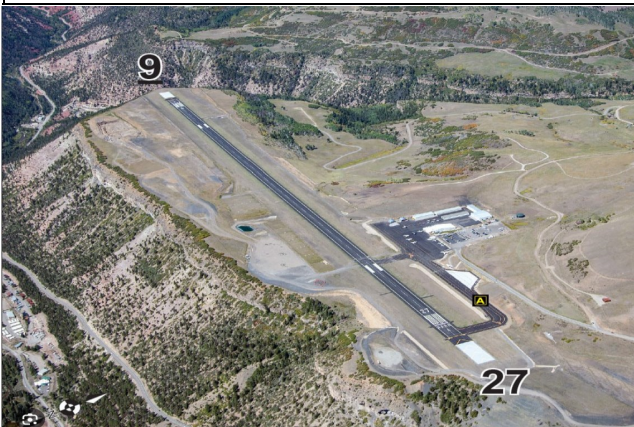
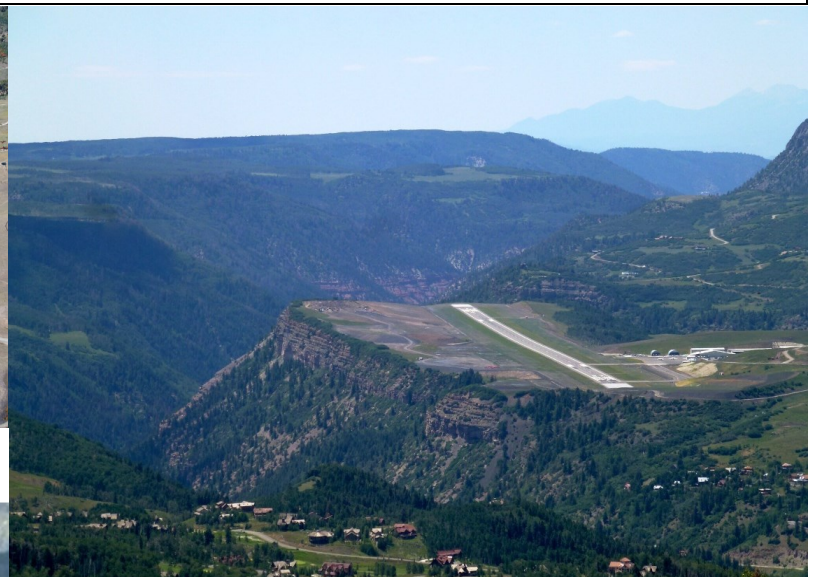
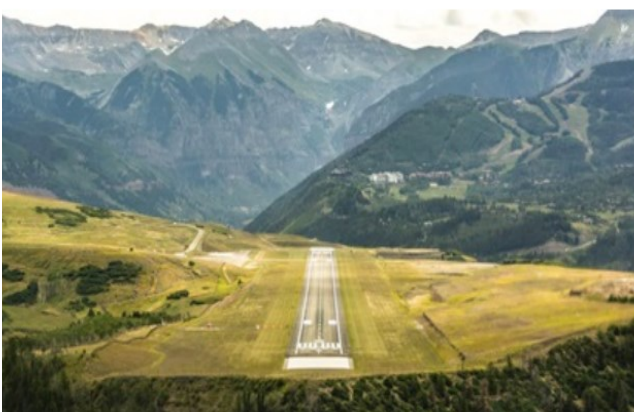
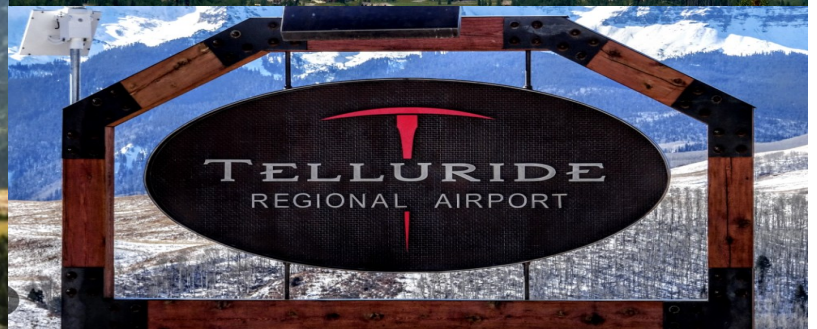
Telluride Airport covers an area of 542 acres at an elevation of 9070 feet above mean sea level. It has one runway: 9-27 is 7,111 by 100 feet with an asphalt surface.

The airport's runway is on a plateau and dips in the center. Terrain around the airfield exceeds 14,000 feet and rises in all quadrants. At the end of the runway there is a 1,000' drop into the San Miguel River below the airport. Runway 9 has a right-hand traffic pattern. Runway 27 is not specified to be right or left, but assumed to be left.

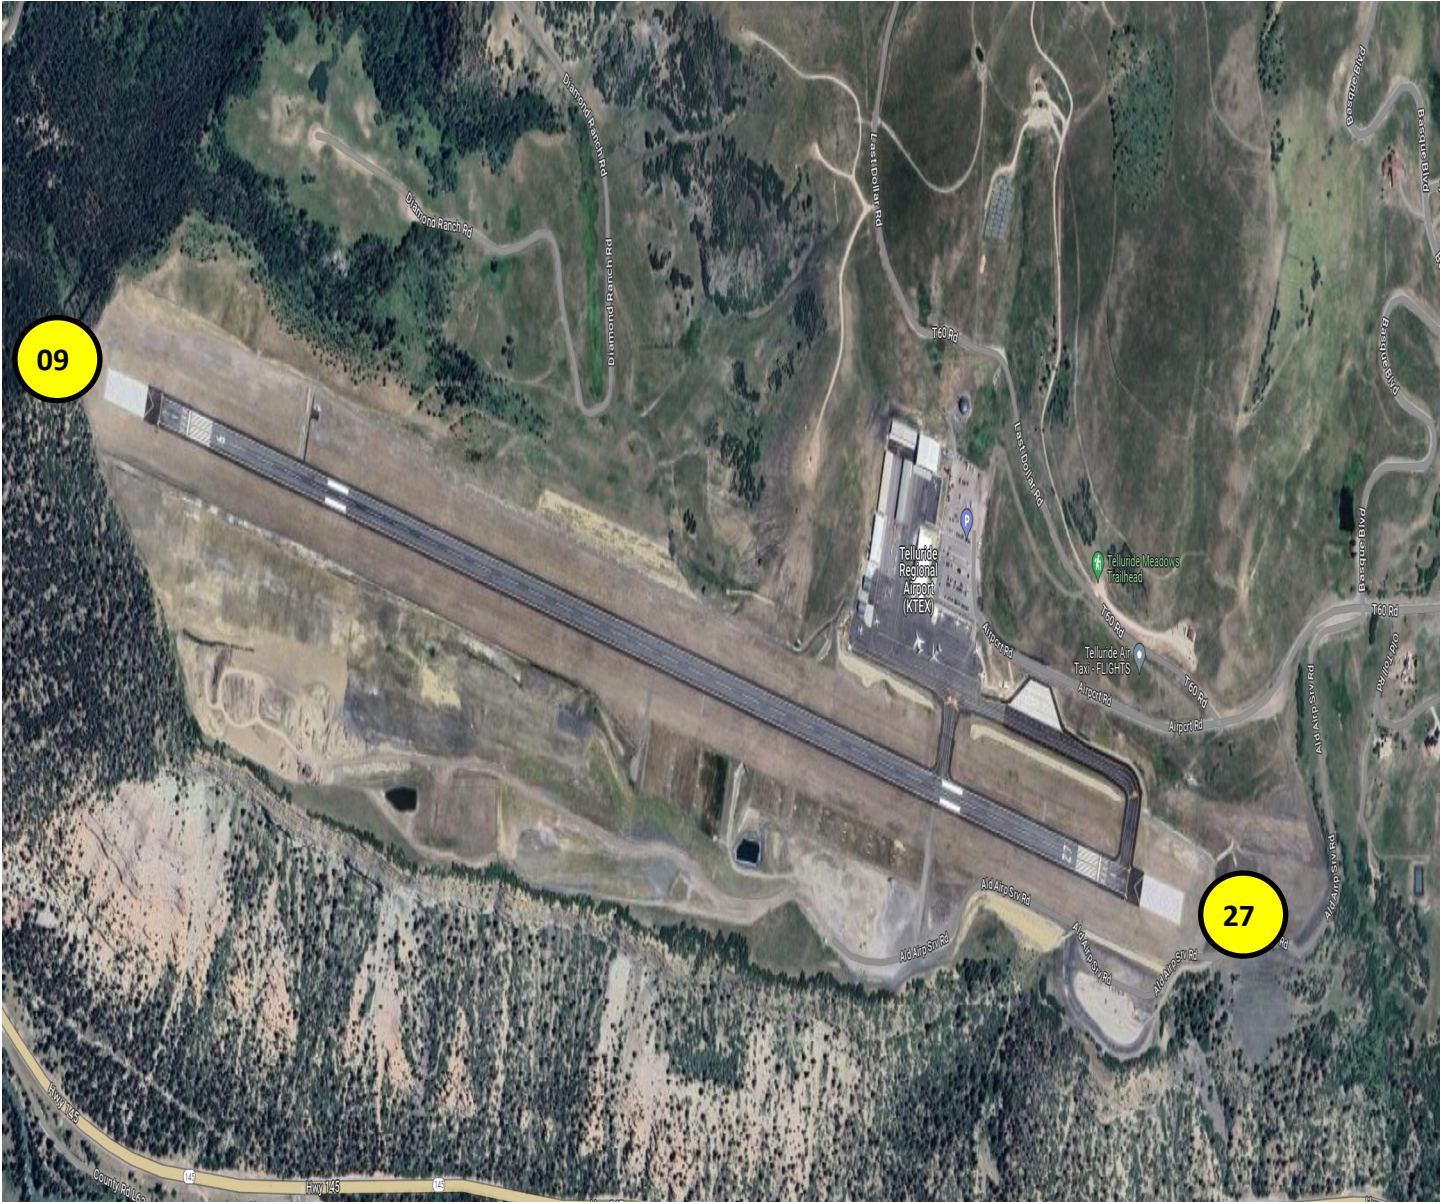
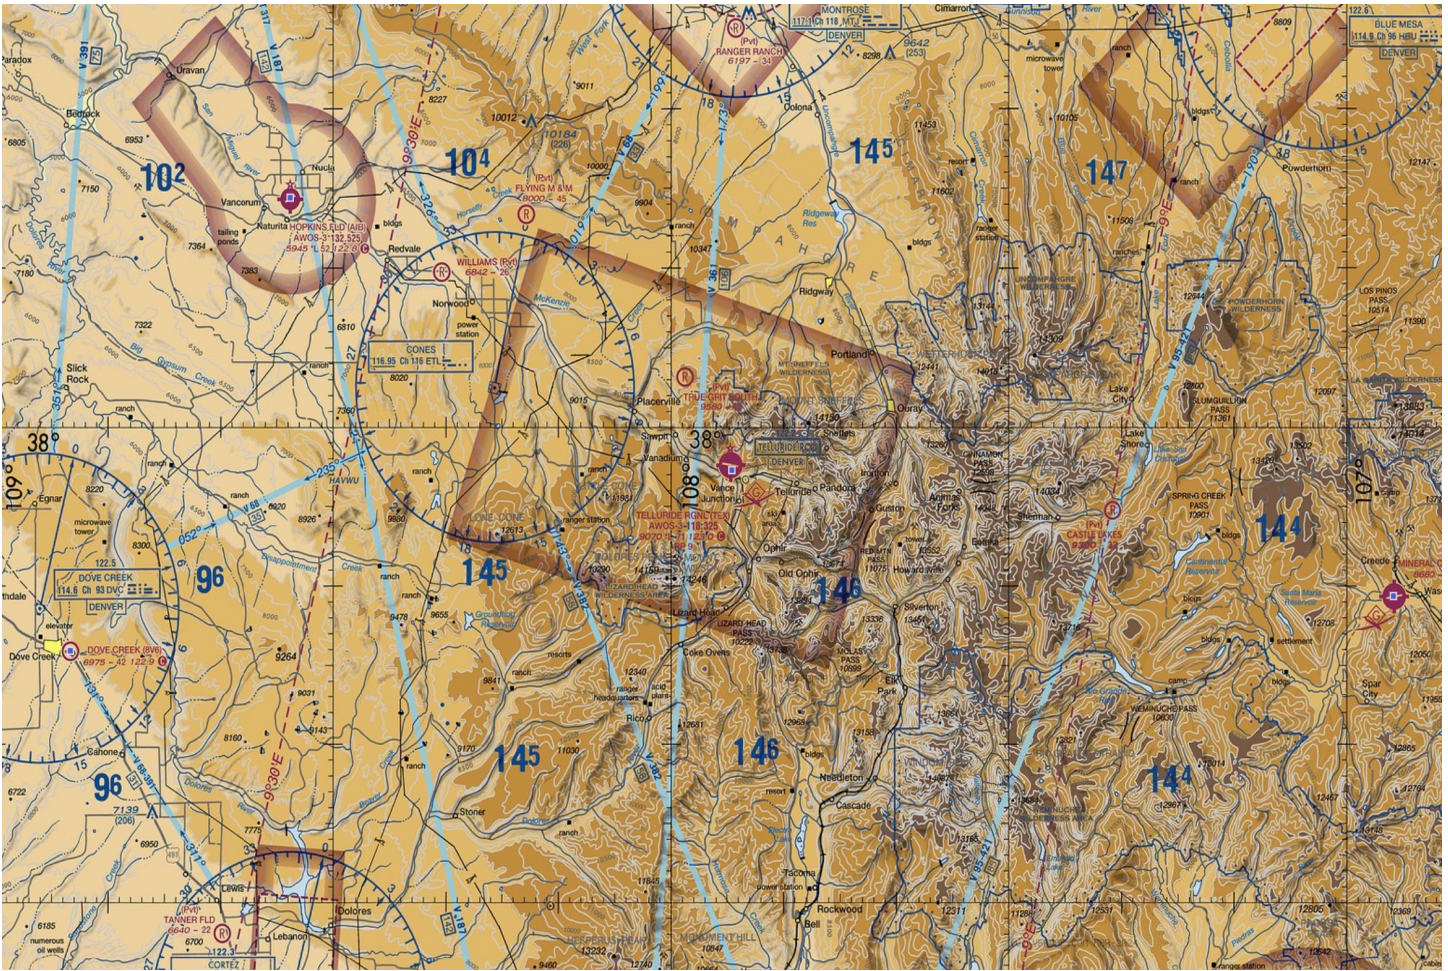
Approach Review

RWY 9	RWY 27
RNAV(GPS), LOC, VOR/DME	VOR/DME
